# ANNUAL REPORT FOR 2010

**Myrick Pond Mitigation Site**  
**Richmond County**  
**TIP No. R-2231**

Prepared By:  
Natural Environment Unit & Roadside Environmental Unit  
North Carolina Department of Transportation  
September 2010

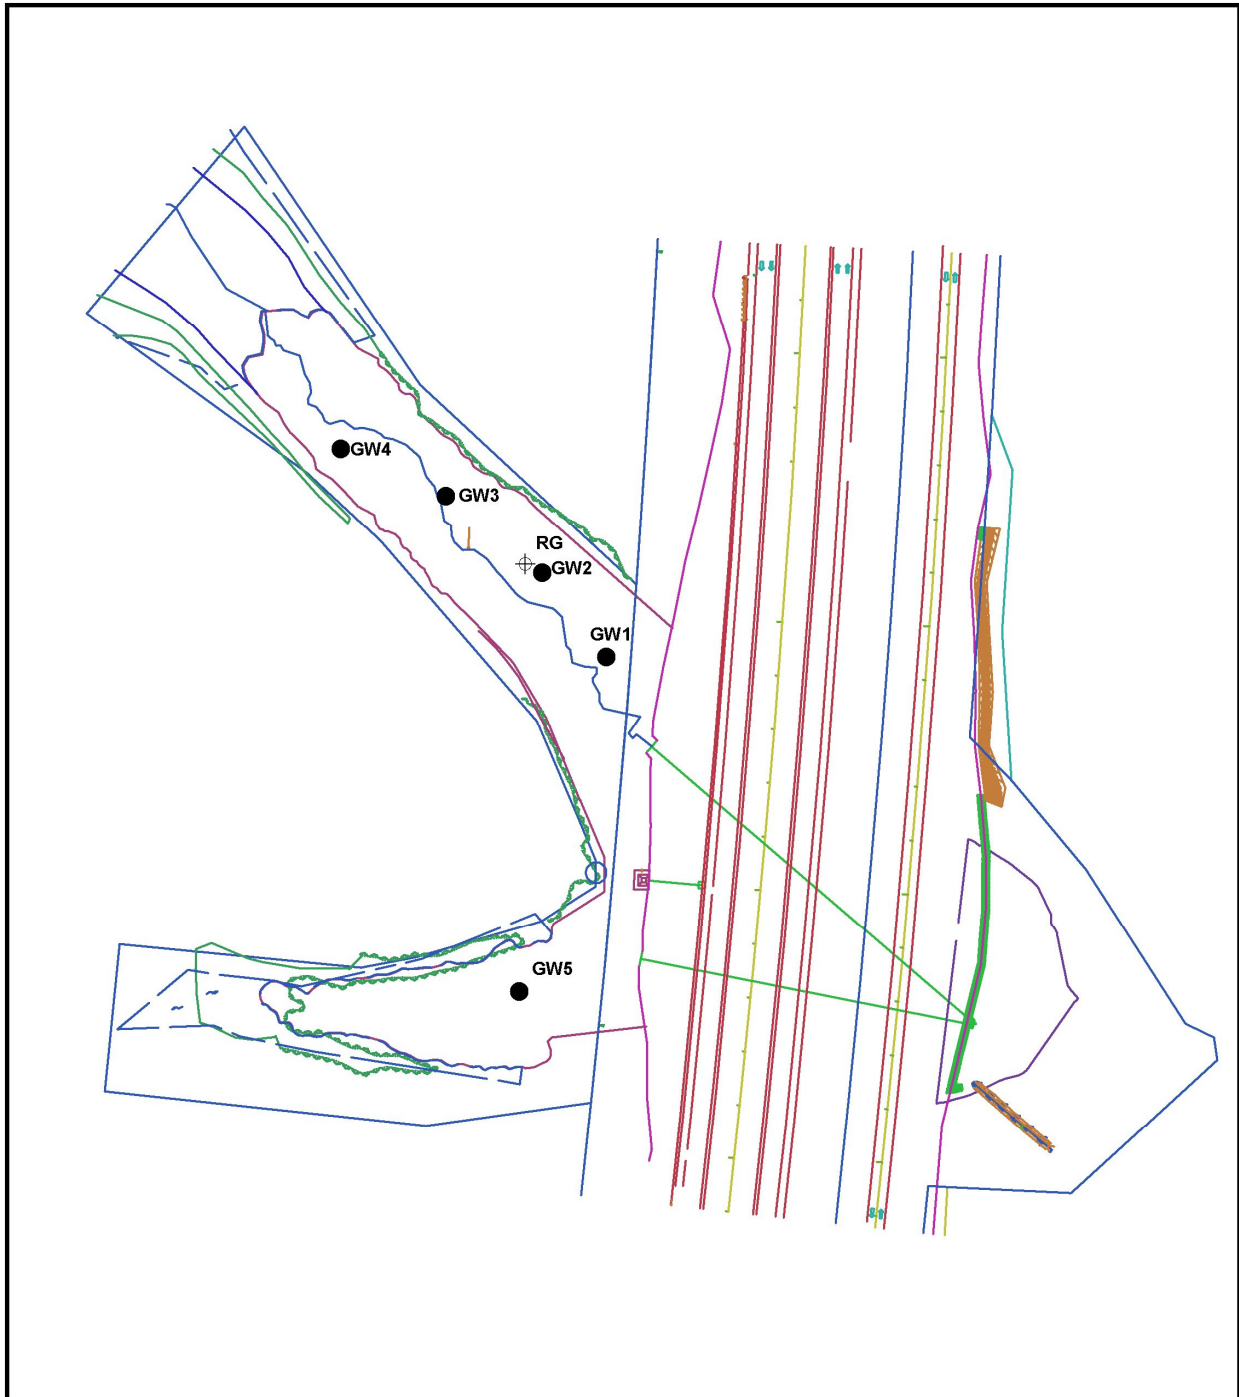
**Figure 2. Gauge Location Map**

Five groundwater monitoring gauges were installed on the site (Figure 2) in February 2007 in the emergent wetland. A rain gauge is also located on the site to assist in comparison of the rainfall data (supplied by the NC State Climate Office) from an official weather station in Hoffman. The groundwater gauges record water levels on a daily basis. Monitoring data for 2010 represents the third year of hydrologic monitoring for the site.

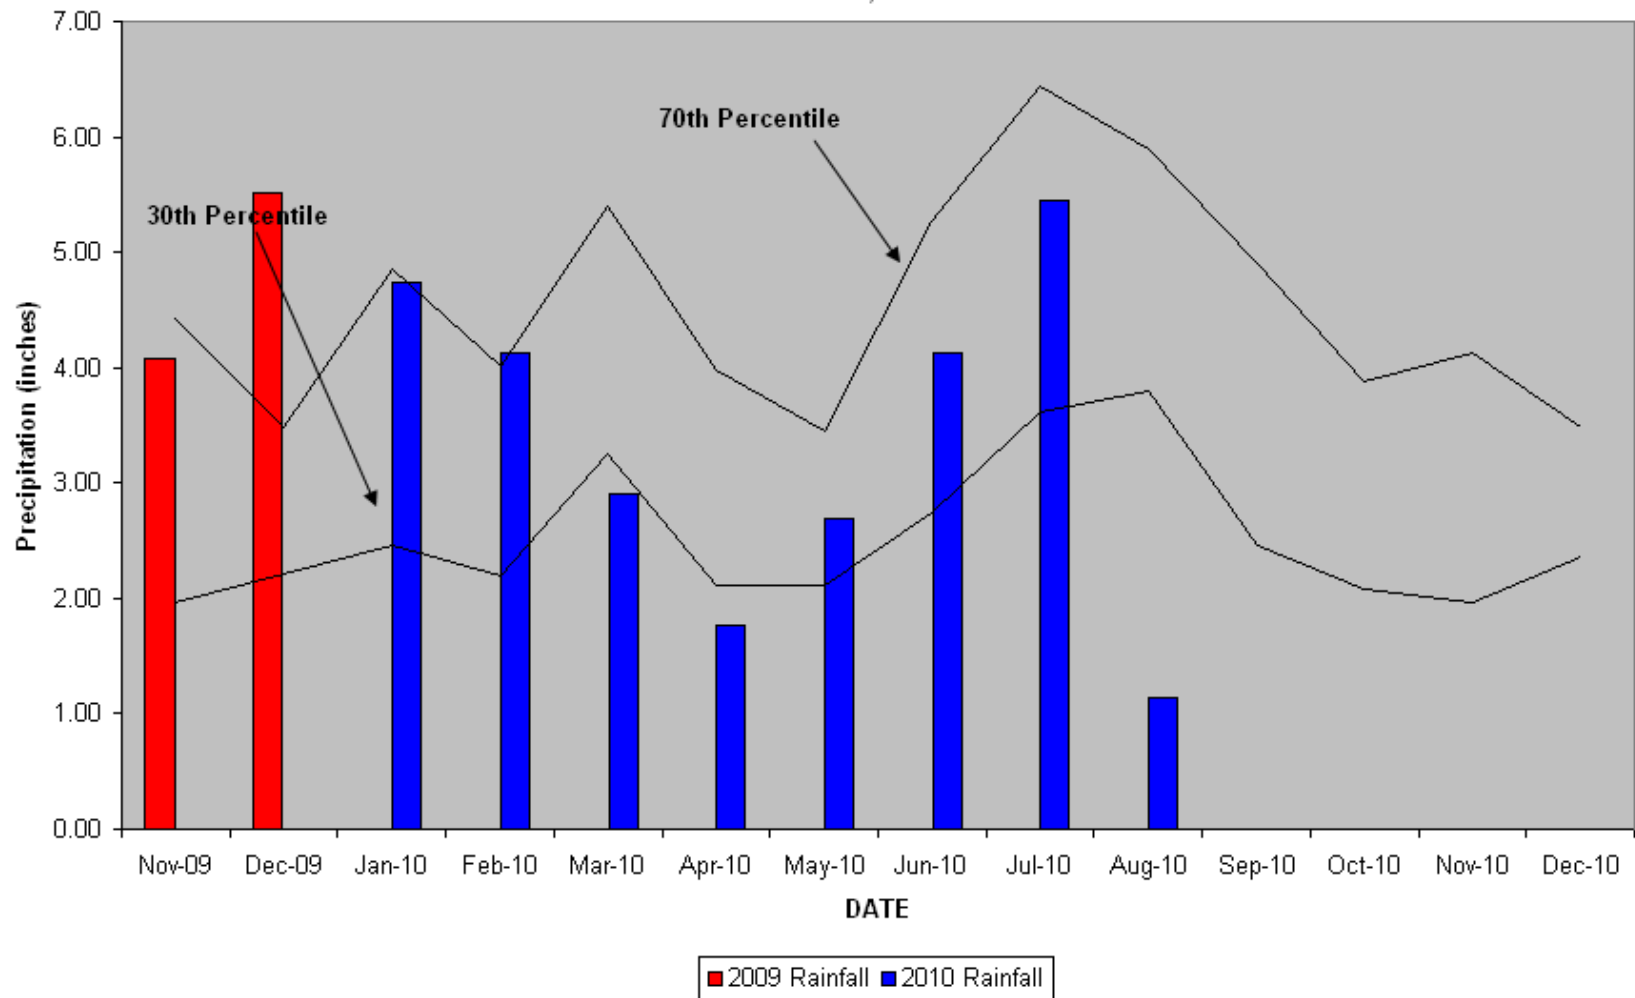
Myrick Pond  
Figure 4 (30-70 Percentile Graph)  
Norman, NC

Figure 4 is a comparison of the 2010 monthly rainfall to the historical precipitation (collected between 1977 and 2009) for Hoffman, North Carolina. This comparison gives an indication of how 2010 relates to historical data in terms of climatic conditions. The NC State Climate Office provided all historical rainfall information. For 2010, March and April recorded below average rainfall. The months of January, February, May, June and July recorded average rainfall. Overall, 2010 was an average rainfall year.

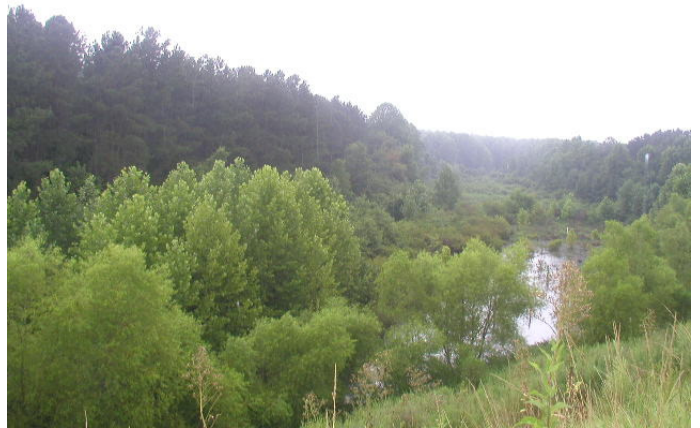
**Site Notes:** Beaver activity continues to be an ongoing issue at the Myrick Pond Site. NCDOT is continually working with USDA beaver trappers to minimize the beaver activity on site. Vegetation Plot #2 was inundated with water due to beaver activity at the time of the monitoring evaluation. Photo point #5 could not be taken due to the high water. All beaver dams have been breached as of August 2010. Other species noted: *Juncus* sp., red maple, goldenrod, cattail, tear thumb, cut grass, sedge, smartweed, briars, pokeberry and various grasses.

Photo Point #6 (Looking Towards Vegetation Plot 2)

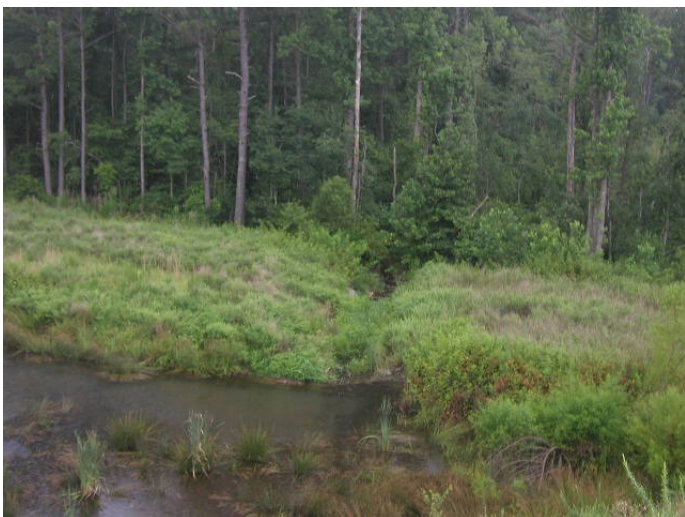
Photo Point #7 (Looking Downstream at the Outlet End of the Box Culvert)
